LDEF — 69 Months in Space

First Post-Retrieval Symposium

Title: LDEF - 69 Months in Space: First Post-Retrieval Symposium, Part 2

Corporate Author Or Publisher: NASA Langley Research Center, Hampton, VA 23665-5225 Report Number: L-17042

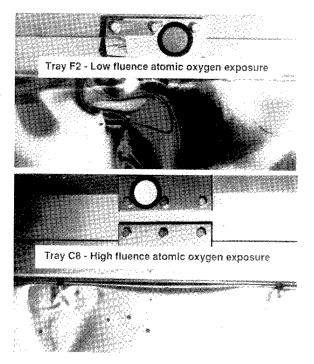
Another example of synergism of low-Earth orbit environmental factors was indicated by the behavior of the A276 thermal control paint disks, as illustrated in fig. 5. The coloration of the disks on the wake-facing surfaces of LDEF, and changes in their thermal control properties discussed later in this report, appears to be caused by vacuum UV effects on the polyurethane binder in the white paint. On the ram-facing LDEF surfaces (exposed to AO), this UV-affected layer was eroded away and the coating remained white, with unchanged thermal control properties. Erosion of the paint binder loosened the outer-surface pigment particles of the paint, some of which may have dislodged from the surface. However, enough pigment was retained to maintain the thermal control property stability throughout the 5.8-year LDEF mission.

The A276 white thermal control coating disks (see fig. 5 and previous discussion) were subjected to general microscopic examination, surface spectroscopy, thermal control property determinations, and cross-section studies at Boeing (ref. 12). The general findings of the surface analyses were that most anomalies on the disks appear to have been a result of preflight handling damage and contamination. The on-orbit contamination film deposited on some of the disks contained silicon dioxide and fluorine.

5. Silvered Teflon (Ag/FEP) second surface mirror thermal blankets and A 276 thermal control paint disks after exposures on LDEF trays F2 and C8.

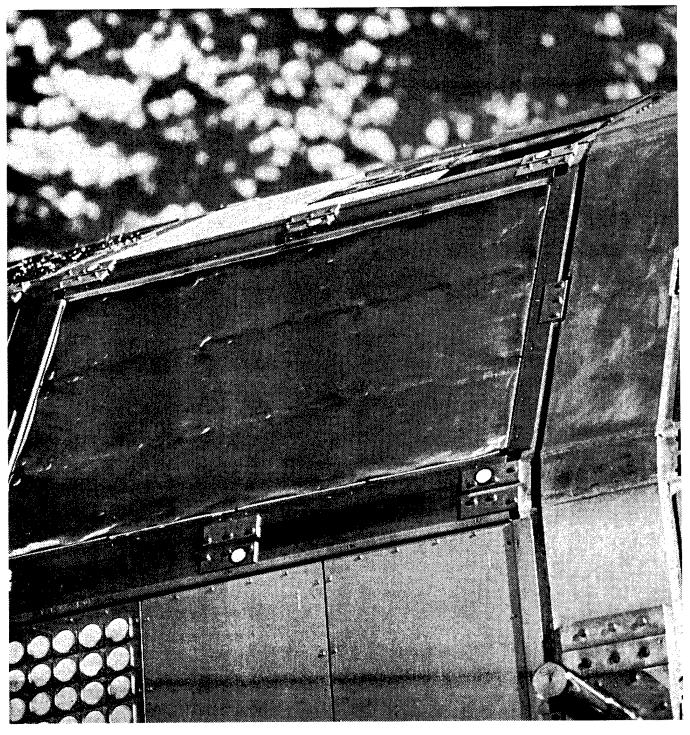
Silvered Teflon thermal blankets were easily penetrated by these impacts. An interesting phenomenon was noted: A delaminated area (vapor-deposited silver/Inconel coating delaminated from the FEP Teflon) from a fraction of an inch to more than one inch in diameter surrounded the thousandth-inch diameter craters made by the meteoroid/debris impacts (figs. 6 and 7). Although the thermal control properties of the Ag/FEP were not generally affected by the LDEF exposures, the thermal behavior of delaminated Ag/FEP is not the same as the original material (see subsequent section) and requires further study.

6. Ag/FEP second surface mirror thermal blanket on LDEF tray D7 showing delaminations (light areas) surrounding meteoroid/debris impacts.

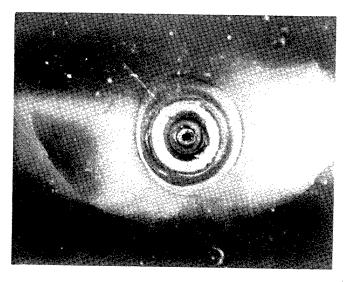
PHOTOMICROGRAPH OF MICROMETERIOD IMPACT ON LDEF SILVERED TEFLON THERMAL BLANKET

7. Micrometeoroid impact on LDEF silvered Teflon thermal blanket material, showing "bullseye" and delamination areas around impact crater.

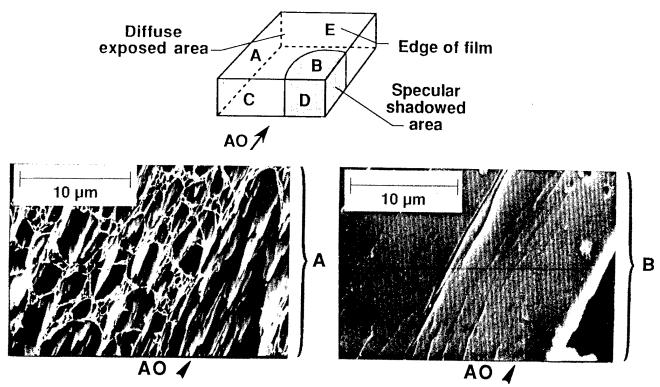
SEM OF LDEF-EXPOSED KAPTON FILM

10. Scanning electron photomicrographs of Kapton film showing grazing angle AO-eroded/diffuse surface in exposed area and unaffected smooth/specular surface in area shadowed by another LDEF surface.

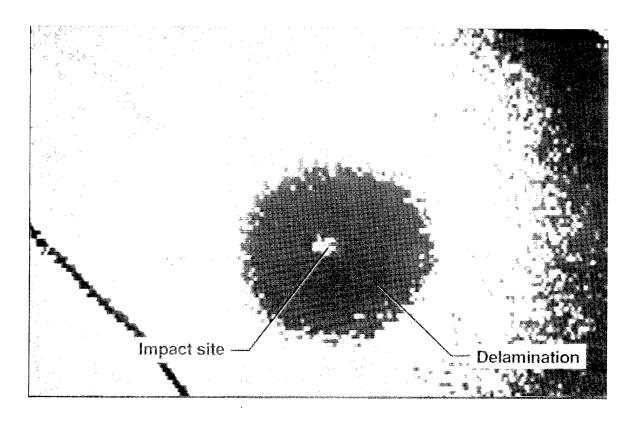
LDEF A0178 Thermal Blanket

As noted previously in this paper, silvered Teflon thermal blankets delaminated at meteoroid/debris impact sites. NASA - Lewis Research Center conducted a test in air to qualitatively determine the effects of the delamination on the thermal behavior of the Ag/FEP blanket material. The results are illustrated in fig. 12. An infrared camera was positioned to directly view the 0.5-mm impact site surrounded by the 10-mm wide delamination. A heating lamp behind the Ag/FEP specimen provided a transient heat pulse. The FEP Teflon surface on the unaffected area of the blanket heated immediately, as indicated by the lighter area in the infrared photograph. The delaminated region (darker region surrounding the perforated impact site) showed a definite thermal lag, indicating that the thermal control properties of Ag/FEP are significantly affected by the delamination. Further studies will be required to quantify this behavior.

- Impact diameter \sim 0.5mm
- $\bullet \ \ Delamination \ \ diameter \sim 10mm$
- Infrared camera photograph
- Transient heating in air

^{12.} Thermal lag in delaminated silvered Teflon second surface mirror thermal control blanket flown on LDEF.

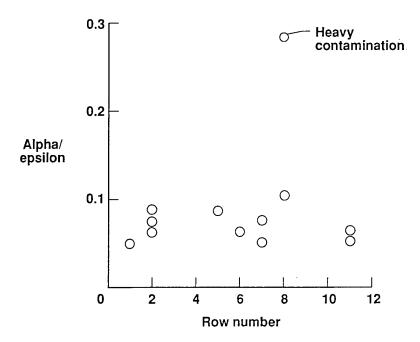
Thermal control properties, α_s and ϵ , were measured at Boeing for LDEF-exposed Ag/FEP blanket material from each of the rows utilized for LDEF experiment A0178 (ref. 11). The results are shown in fig. 13. Specimens in rows 6 through 11 had diffuse surfaces due to AO erosion while specimens from rows 1 through 5 were specular, similar in appearance to unexposed (control) material. No significant differences were noted in α_s/ϵ ratio for these specimens (fig. 13), excepting for a dramatic increase in α/ϵ for the specimen in row 7 that has a heavy contamination layer on it.

13. Solar absorptance/thermal emittance ratios for silvered Teflon thermal blankets after LDEF exposure.

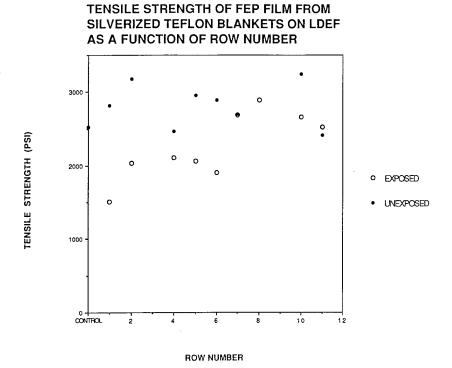
Mechanical property measurements on the Ag/FEP blankets (ref. 11) included tensile strength and elongation and dynamic mechanical analysis. The tensile strengths of the exposed films are shown as a function of LDEF row number in fig. 14. Strengths were measured on samples exposed to the LEO environment and on control specimens on the same blankets which were folded under the sides of the trays and thus not exposed to AO, solar radiation, etc. In the areas of high AO fluence, rows 6 through 11, no significant differences in tensile strength were noted between exposed and unexposed specimens. The blanket specimen cross sectional areas have been measured to include the effects of FEP erosion in the strength calculations. In the areas of low AO fluence (rows 1 through 5), however, the tensile strength of the Ag/FEP was degraded by approximately 30%. This implies that solar UV radiation combined with the other LEO environmental factors, but in the absence of atomic oxygen erosion, has affected at least the surface of the FEP Teflon. Considerations of this phenomenon are presented in ref. 9. Further studies are required to determine the detailed mechanism(s) of this degradation. Surface analyses of the AOaffected Ag/FEP blanket materials were conducted at Boeing using optical microscopy, scanning electron microscopy, scanning ion mass spectrometry, and electron spectroscopy for chemical analysis. The results supported an AO erosion mechanism causing the characteristic "microforest" morphology with no indication of FEP surface chemistry change due to chemical interactions with AO. Analyses at NASA - Langley confirmed these findings.

14. Tensile strengths of silvered Teflon thermal blanket specimens exposed to LDEF space environment parameters and specimens on LDEF shielded from the space environment (unexposed).

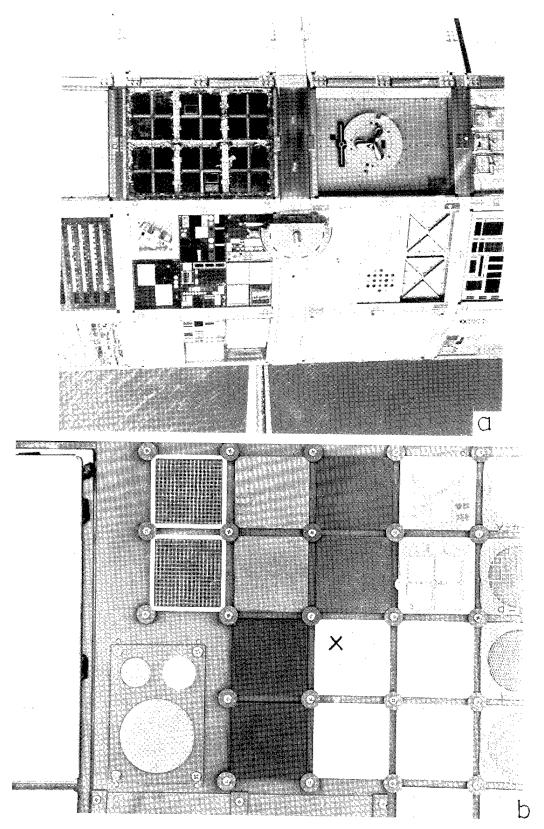
FIG. 2: Orbital view of LDEF during retrieval showing damaged silver-coated teflon thermal blanket and specimen arrays in a bay area including M0003 on the leading edge of the satellite (a). An enlarged view of the specimen area included in this investigation and shown in (a) is illustrated in (b).

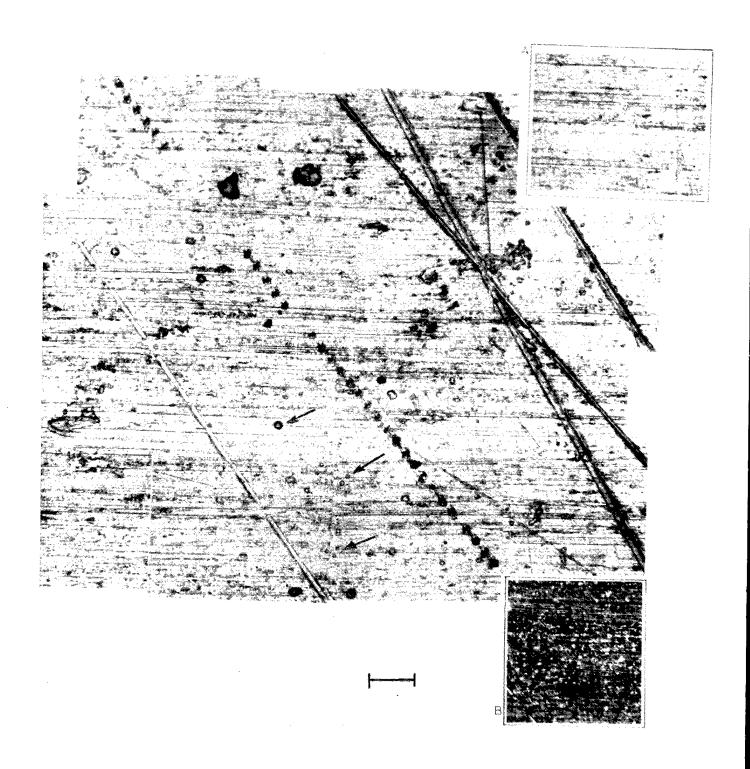
FIG. 4: Optical micrograph composite of surface area on aluminum alloy test plate near the leading edge of LDEF marked X in Fig. 1(c). Insert A shows a typical view from the reverse (unexposed) side of the test plate while insert B shows a 2X view of a region from the exposed side shown in the composite. The arrows illustrate blisters on the surface magnification marker = $10 \,\mu m$.

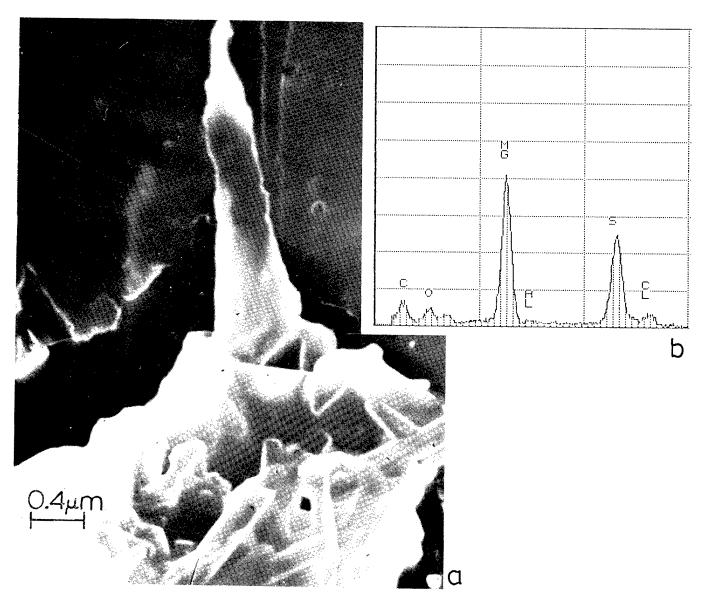
FIG. 10: Mg-S-O particles embedded in a carbon support film which have been lifted from the aluminum alloy test panel surface and examined in the analytical TEM. (a) SEM mode view of particle cluster. (b) EDS spectrum. Note absence of aluminum peak in contrast to Fig. 9(b).

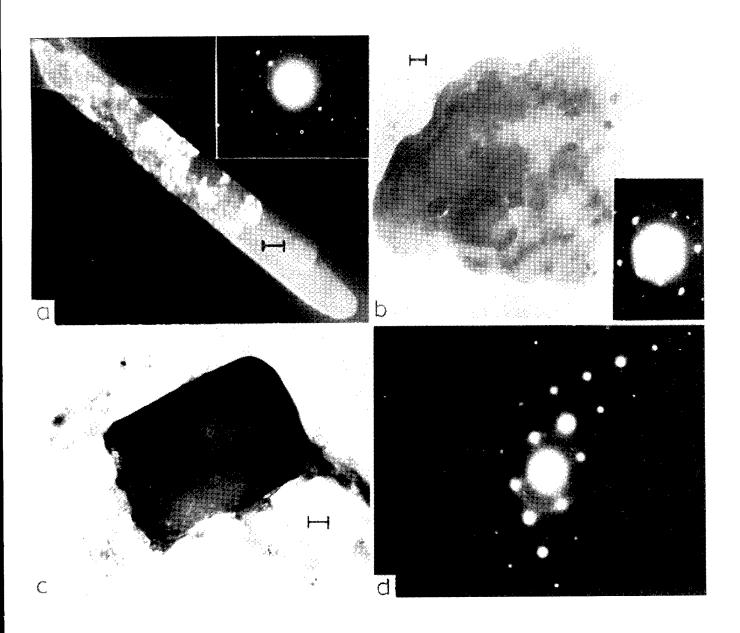
FIG. 11: Examples of isolated particulate analysis in the analytical TEM of LDEF leading-edge aluminum 6061-T6 test panel surfaces. (a) Dark-field TEM image and SAD pattern insert for Al-O crystals containing inclusions. (b) Bright-field TEM image and SAD pattern insert for Mg-S crystal. (c) Bright-field TEM image of NaCl crystal. (d) SAD pattern showing cubic symmetry for (c). Magnification markers are $0.1\,\mu m$.

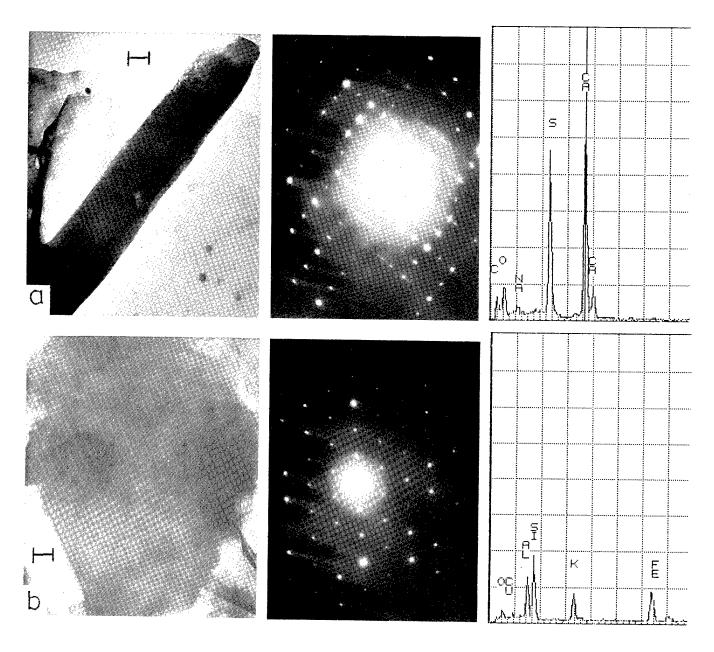
FIG. 12: (a) Example of gypsum (Ca-S) crystals. (Bright-field TEM image. Magnification marker is 0.1 μ m.; SAD pattern; EDS spectrum). (b) Example of silicate particle. (Bright-field TEM image. Magnification marker is 0.1 μ m.; SAD pattern; EDS spectrum).

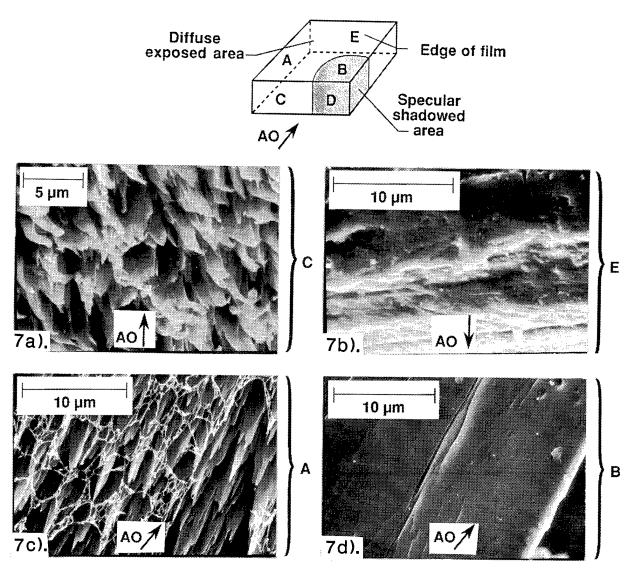
Figure 7. SEM of LDEF-exposed Kapton Film.

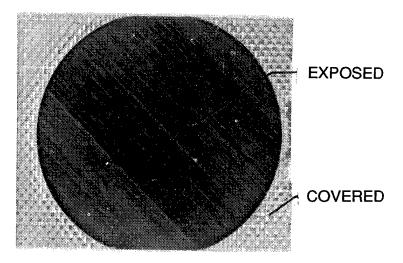
Figure 8. LDEF exposed P1700/C6000 polysulfone (± 45°)s composite.

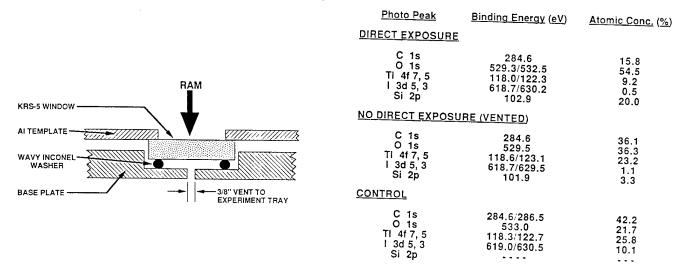
Figure 12. LDEF-exposed KRS-5 optical window.

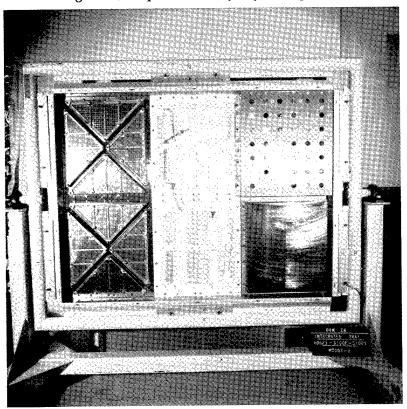
Figure 2, Experiment tray after exposure.

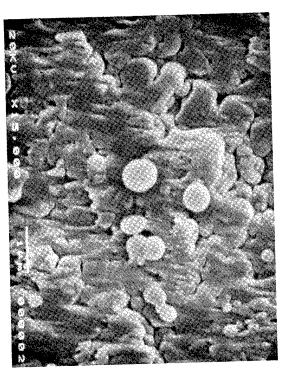
Figure 15b, SEM micrograph of the exposed HDPE/LLDPE surface.
Micrograph was recorded with a 10° tilt.

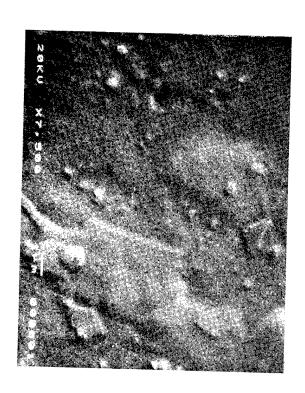
Figure 18 is a SEM micrograph of the control FEP copolymer taken from a leading edge thermal blanket. Both the control and exposed FEP samples were taken from the same strip of material. The control was taken from that portion of the material protected from direct exposure to UV radiation and atomic oxygen.

Figure 18, SEM micrograph of control FEP copolymer.

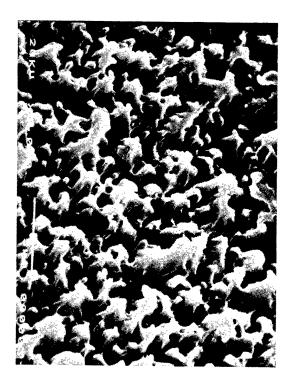
The surface of the exposed FEP is shown in Figure 19. The surface appears to have been significantly roughened with sharp peaks angled towards the direction of atomic oxygen flow. These micrographs suggest that atomic oxygen and VUV radiation, acting in concert, degrade FEP and that the atomic oxygen flux is highly directional in its erosion of the surface. This is in agreement with observations made by Stiegman et al. (ref. 7), not only for FEP samples exposed aboard LDEF, but also for FEP samples taken from a hyperthermal atomic oxygen simulator. Preliminary FTIR data (not presented here) suggest little change to the chemistry of the polymer in terms of branching or crosslinking. This does not imply that atomic oxygen induced degradation has not occurred.

Figure 19, SEM micrograph of exposed FEP copolymer.

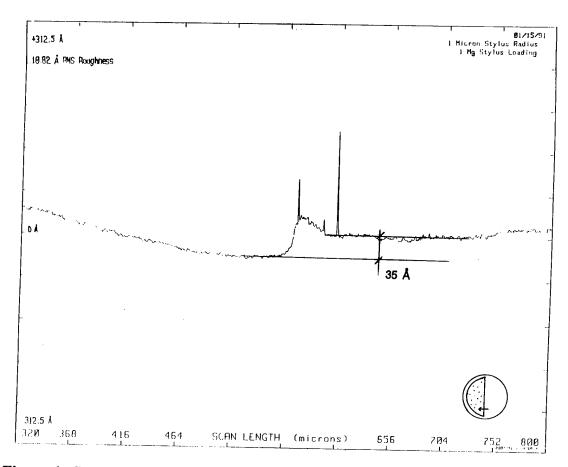
Figure 4. Surface profile of transition from unexposed to exposed of Iridium film

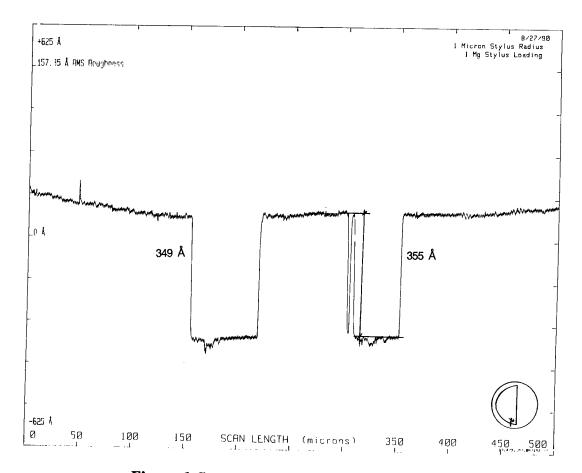
Figure 6. Surface profile of exposed Gold film

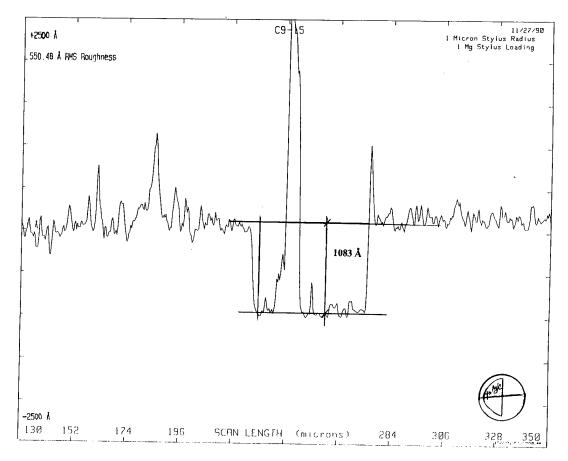
Figure 8. Surface profile of exposed Silver over Carbon film

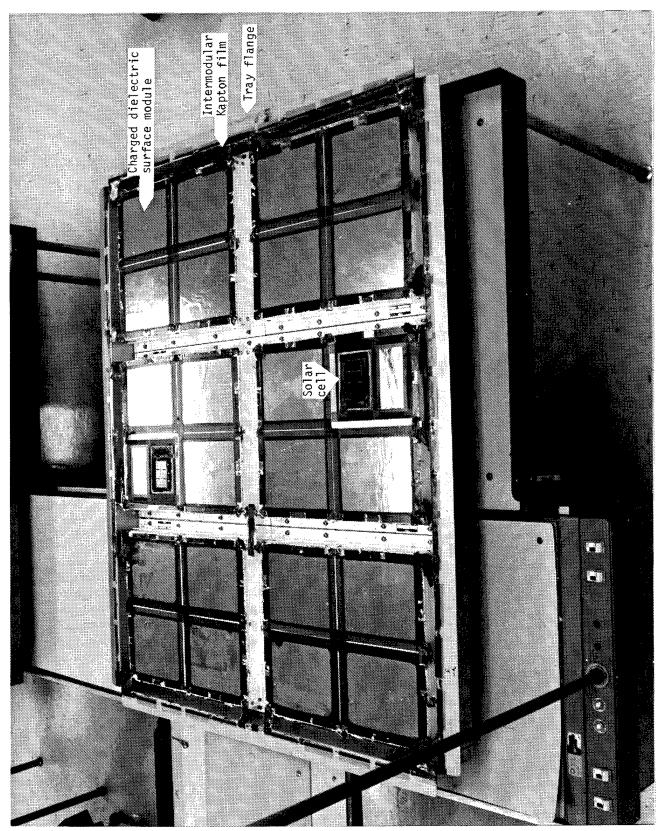
Figure 1. Ram-Facing SP-HVDE Tray (Post Flight)

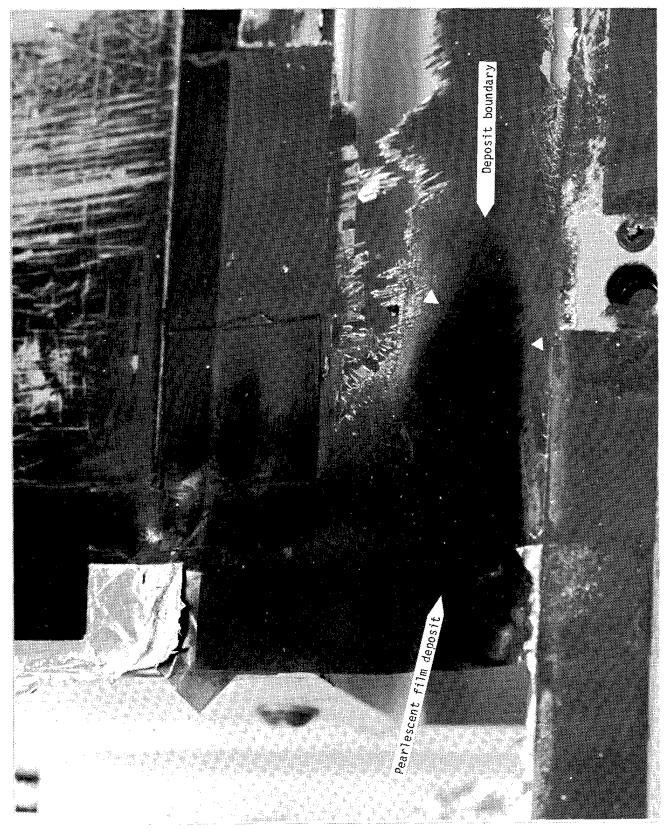
Figure 9a. Hypervelocity Impact Crater on Ram-facing Tray Flange. Figure 9b. Edge-on Close-up of "Petals". Figure 9c. Crater Floor.

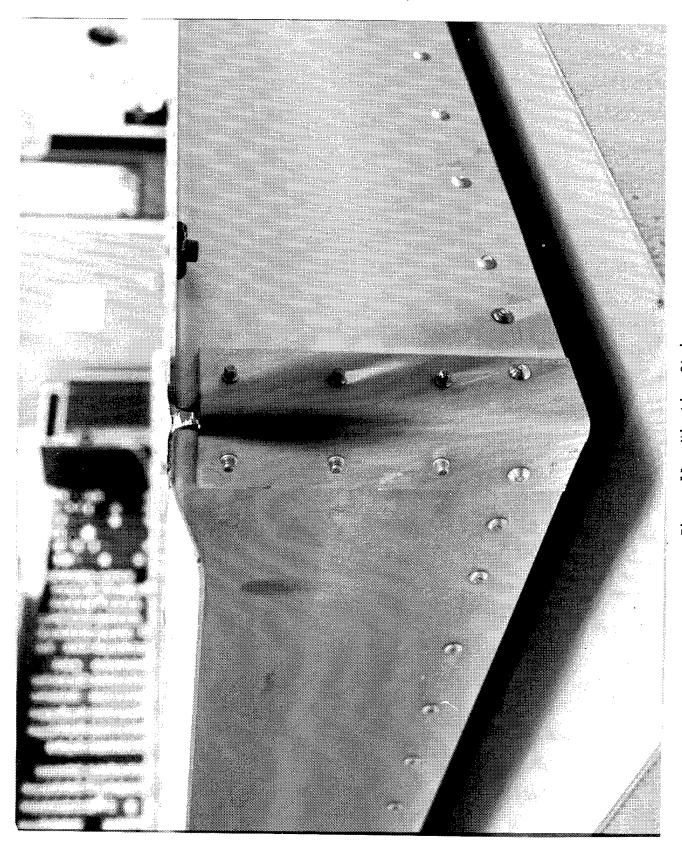
Figure 10. Pearlescent Outgassing Deposit on Kapton

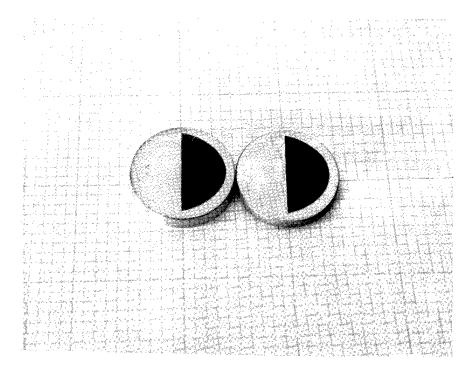
While selective modification occurred only in the ram direction, expansion of the exposed film was consistent with partial conversion to an oxide, and other supportive evidence suggests that the copper was modified by heavy oxidation in the areas exposed to the orbital ram. We lack full confirmation that this is the cause at this time.

Figure 1: Photograph of the bulk and thin film copper samples from C9 tray

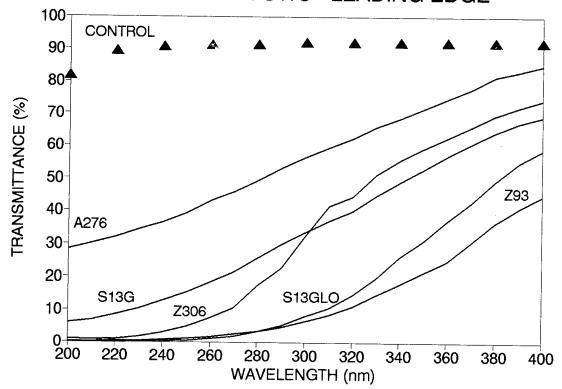
The visible darkening of the flight windows and the measured degradation in ultraviolet transmittance are significantly greater for the windows from the Leading Edge unit compared to the windows exposed to similar coatings on the Trailing Edge. Since the inner surfaces of the sealed (teflon gasket) windows are not exposed to atomic oxygen, one cause for enhanced deposition on Leading Edge windows may be thermal in origin, arising from different susceptibilities to deposition as a result of more rapid cooling during sun/shadow transitions for

The intended function of the windows on the Leading Edge, as a measure of controlled (uv only) exposure, was severely compromised by the uv-absorbing contaminant layers. Sufficient throughput of solar ultraviolet radiation for significant interaction and degradation of the underlying coating was detected for the "window-exposed" A276 specimen. The less contaminated windows of the Trailing Edge unit can be seen as more efficient, though not full function, transmitters of solar uv radiation for the radiation-sensitive coatings.

FIGURE 6. UV WINDOW TRANSMISSION LOSS - LEADING EDGE

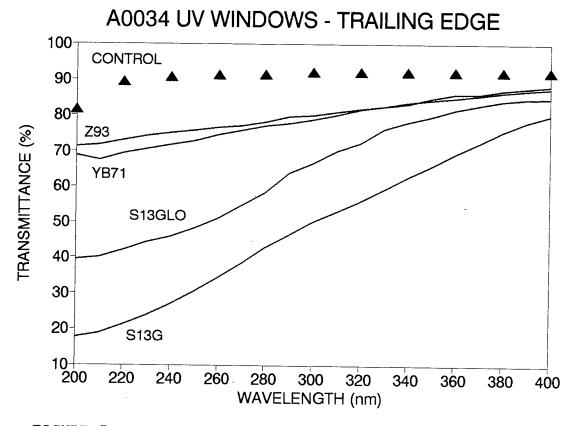
FIGURE 7. UV WINDOW TRANSMISSION LOSS - TRAILING EDGE

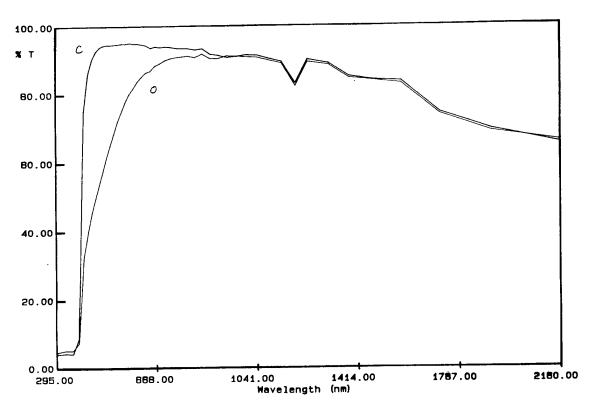
FIGURE 8. OPTICAL DEGRADATION OF S13G-LO (TRAILING EDGE)

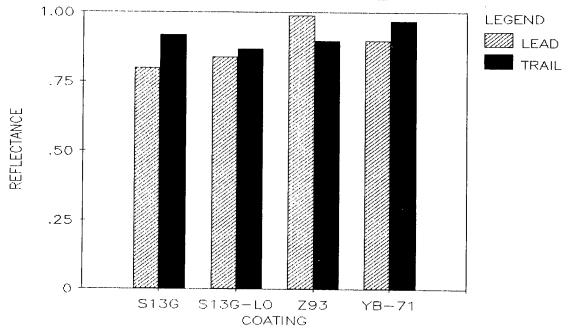
The reflectance degradation of collector mirrors from the Trailing Edge unit is generally less than for mirrors associated with similar coatings on the Leading Edge (Figure 10). The basic evidence for enhanced outgassing, and therefore greater collector mirror deposition and degradation, exists in the levels of systematically decreased reflectance of collector mirrors associated with significantly outgassing coatings exposed uncovered on the Leading Edge, compared to lesser levels of degradation for the same coatings with exposure in the absence of atomic oxygen (Figure 11). Another series of optical measurements sensitive to contaminant layer thickness, using an automated ellipsometer (Gaertner L115B), also indicated a systematic pattern of enhanced degradation for collector mirrors exposed to uncovered (open) thermal control coatings on the Leading Edge.

FIGURE 10. COLLECTOR MIRROR REFLECTANCE - LEADING VS. TRAILING

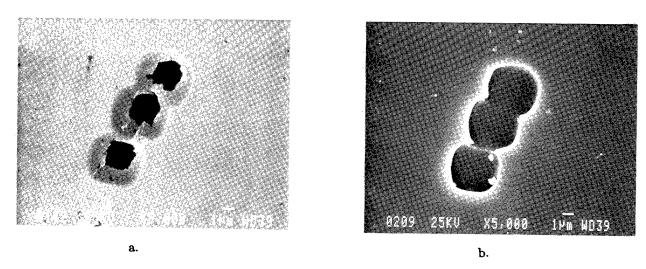
Figure 8. Atomic oxygen undercutting at pin holes defects on LDEF aluminized-Kapton MLI exposed to an atomic oxygen fluence of 5.77 x 10²¹ atoms/cm²: a. with aluminum, b. aluminum chemically removed.

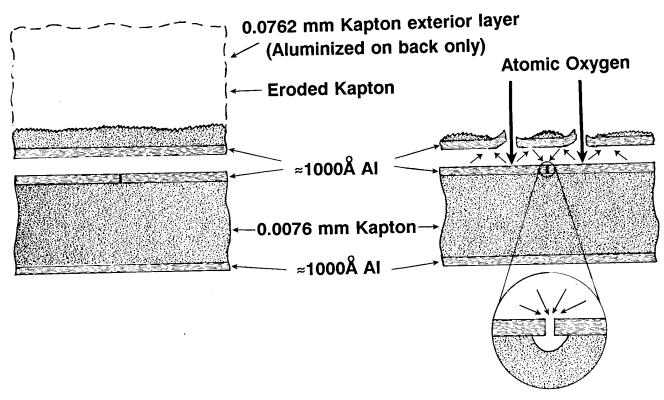
Figure 9. Scattering of atomic oxygen due to partial loss of the Kapton cover layer.

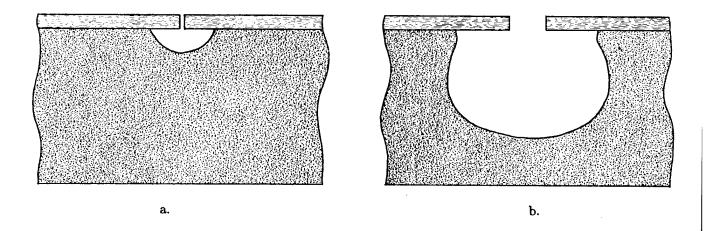
Figure 11. Atomic oxygen undercut profiles of LDEF aluminized-Kapton: a. narrow cracks ($<0.1 \mu m$), b. wide cracks ($>0.1 \mu m$).

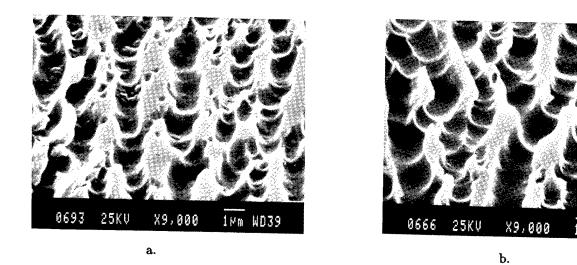
Figure 15. Wide cracks in aluminized-Kapton MLI sample: a. horizontal undercut profiles, b. vertical undercut profiles.

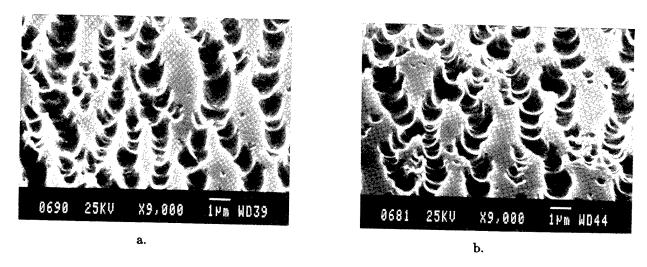
Figure 16. Narrow cracks in aluminized-Kapton MLI sample: a. horizontal undercut profiles, b. vertical undercut profiles.

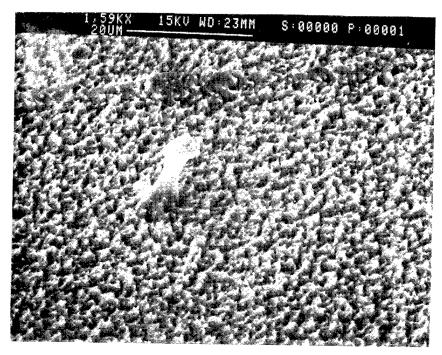
FIGURE 5. - FEP TEFLON FROM ROW 10, WHICH WAS EXPOSED TO AN ATOMIC OXYGEN FLUENCE OF 7.78 X 10²¹ ATOMS/CM², WHICH ARRIVED AT 22 DEGREES FROM THE SURFACE NORMAL.

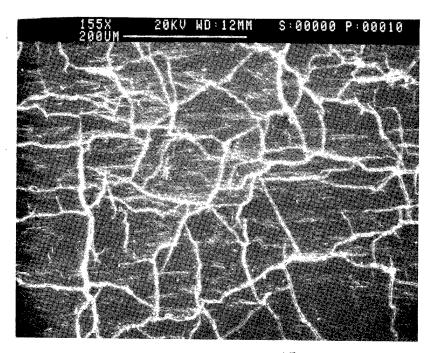
FIGURE 10. - SCANNING ELECTRON PHOTOMICROGRAPH OF THE SURFACE OF A SILICONE-COATED BICYCLE REFLECTOR AFTER SIGNIFICANT ATOMIC OXYGEN ATTACK.

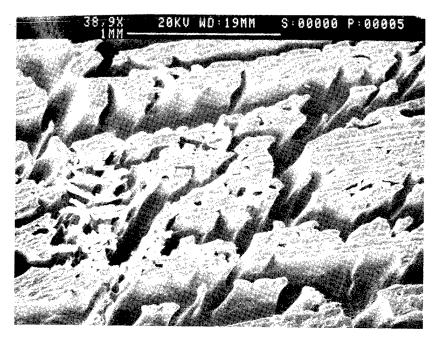
FIGURE 11. - SCANNING ELECTRON PHOTOMICROGRAPH OF SILICONE ADHESIVE FROM KAPTON TAPE AFTER EXPOSURE TO AN ATOMIC OXYGEN FLUENCE OF APPROXIMATELY 4.92 X 10²¹ ATOMS/CM².

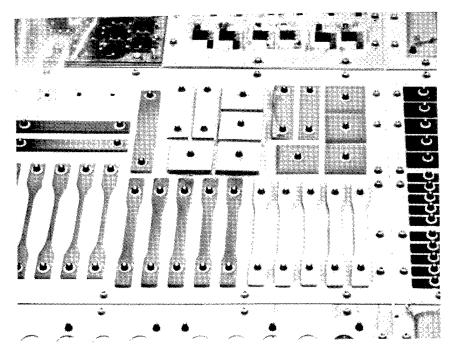
(A) POST-RETRIEVAL PHOTOGRAPH SHOWING DARK CONTAMINATION TO THE RIGHT OF THE SILICONE SAMPLES, BUT SEPARATED FROM THEM BY A LIGHTER-COLORED REGION WHICH WAS SHIELDED FROM ATOMIC OXYGEN.

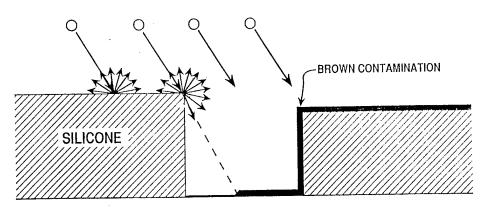
(B) SECTION VIEW SCHEMATIC DRAWING OF ATOMIC OXYGEN ATTACK AND RESULTING CONTAMINATION.

FIGURE 12. - ATOMIC OXYGEN INTERACTION WITH SILICONES PRODUCING A DARK, VACUUM-CONDENSIBLE CONTAMINANT ON ADJOINING SURFACES.

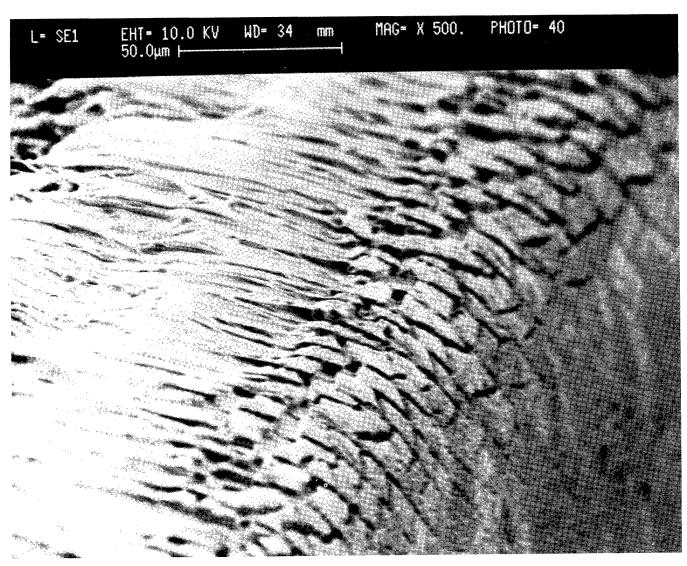
An SEM image obtained at a x500 magnification of the sheared edge of the trailing edge exposed material from the P0004 experiment is presented in figure 2. In stark contrast to the control material, the trailing edge material shows evidence for a highly embrittled layer on outer surface of the FEP. The cutting operation has induced fracturing of this layer. As the underlying material deformed, the embrittled material separated into island-like fragments which appear to flow downward over the sheared edge. A more detailed view of the fragmented surface is shown in figure 3 at a magnification of x4000. From this view the thickness of the highly embrittled layer is estimated to be just over 1 micron. The distinct and sharply fractured features indicate the mechanical properties of the outermost surface have been dramatically altered as a result of almost six years exposure to the space environment.

Figure 2. SEM image of sheared edge of trailing edge LDEF Ag/FEP specimen from showing embrittled surface layer (magnification: x500).

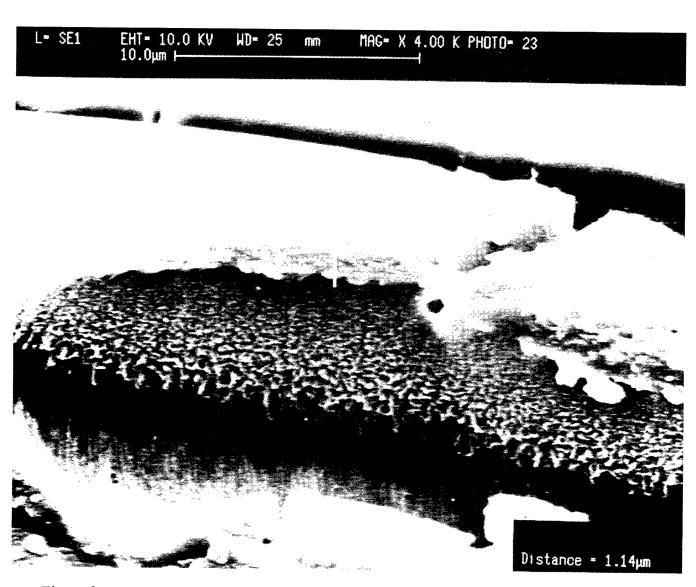
Figure 3. Detailed SEM image of trailing edge (P0004) LDEF Ag/FEP surface note the approximately 1 micron thick fragile layer.

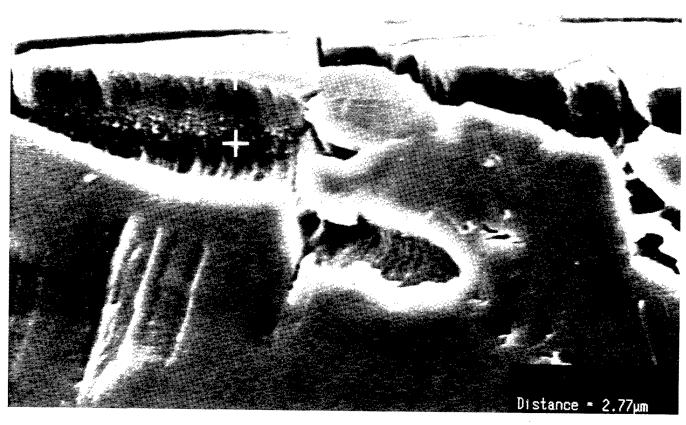
decrease in transmittance is attributed to an increase of light scattering by the film. After the 92-day exposure, the film was cut and the surface examined by SEM. As witnessed in figure 6, the exposed FEP developed an embrittled surface layer similar to that observed in the LDEF trailing edge material (see figure 3).

Figure 6. Detailed SEM image of the embrittled layer observed in sheared FEP exposed to a deuterium lamp for 92 days.

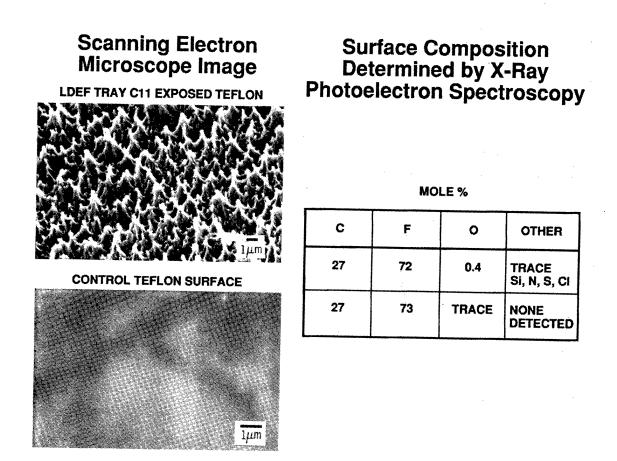
Figure 3. Leading edge sample of Ag/FEP compared to control sample. Typical results of analyses with SEM and XPS.

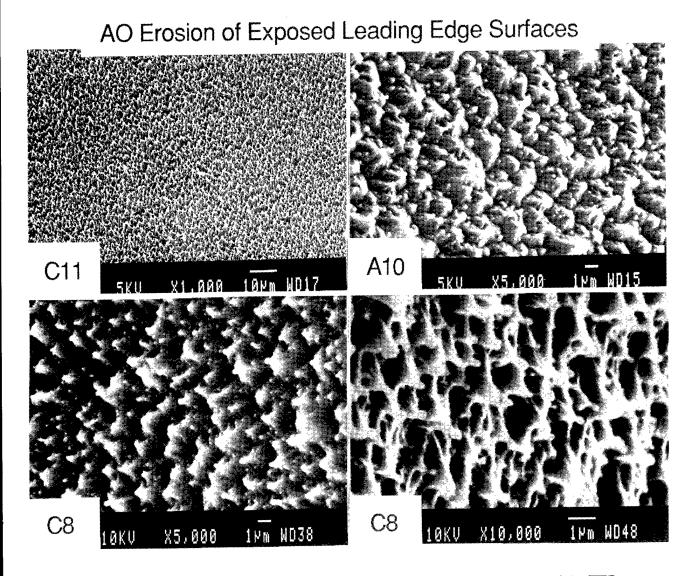
Figure 4. Some variations in the erosion pattern on leading edge samples of Ag/FEP.

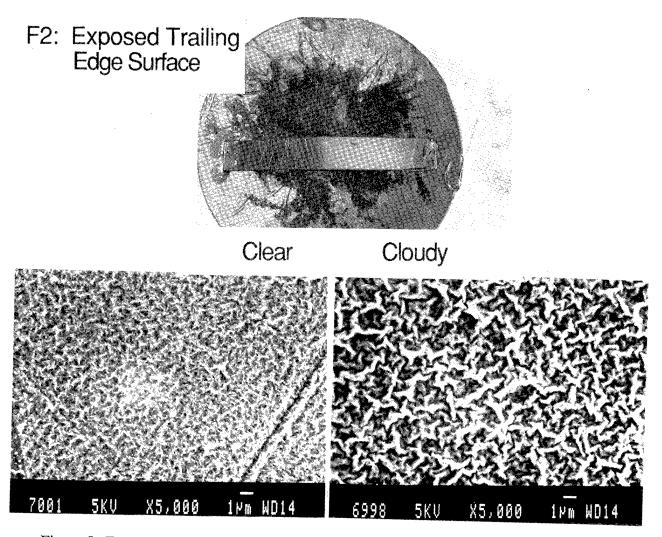
Figure 5. Exposed trailing edge surface from F2 showing morphology changes by SEM in adjacent clear and diffuse areas of Teflon.

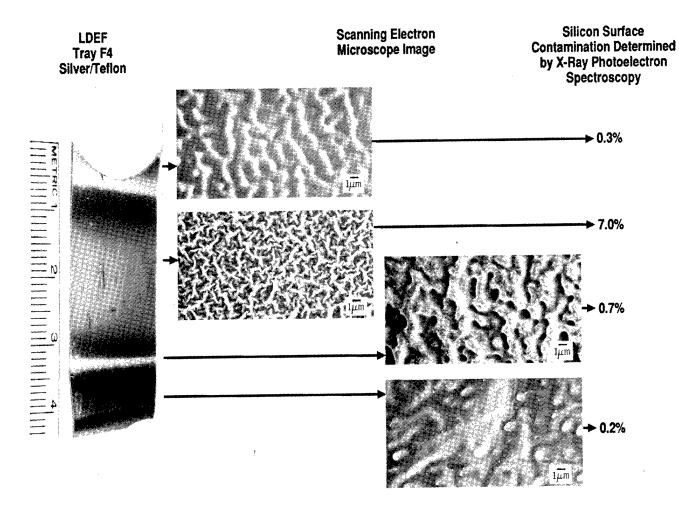
Figure 6. Changes in Teflon surface morphology and surface contamination level, as represented by Si concentration, for a series of adjacent bands on an exposed trailing edge surface from F4.

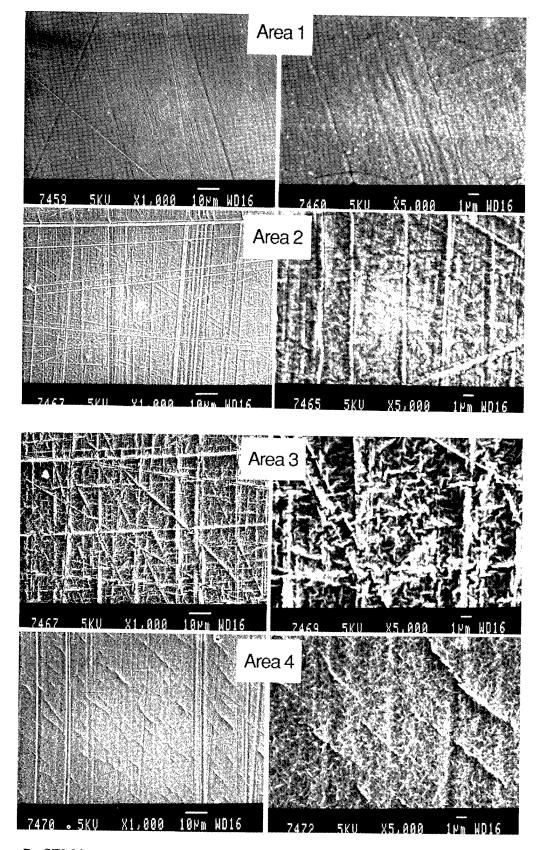
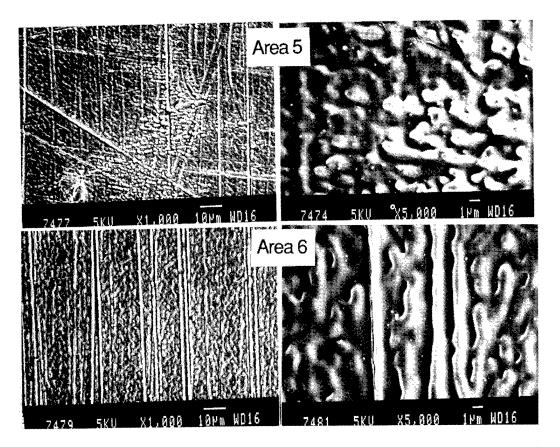
Figure 7. SEM images of morphologies in a series of 6 closely spaced bands on a section of exposed Teflon from trailing edge A2.

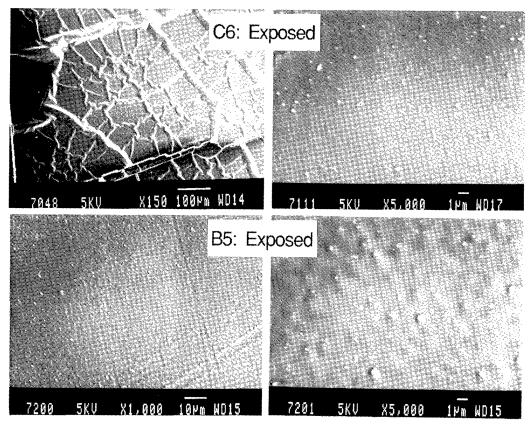
Figure 8. Exposed trailing edge surfaces that are still relatively smooth. Bright spots are relatively high in Si concentration.

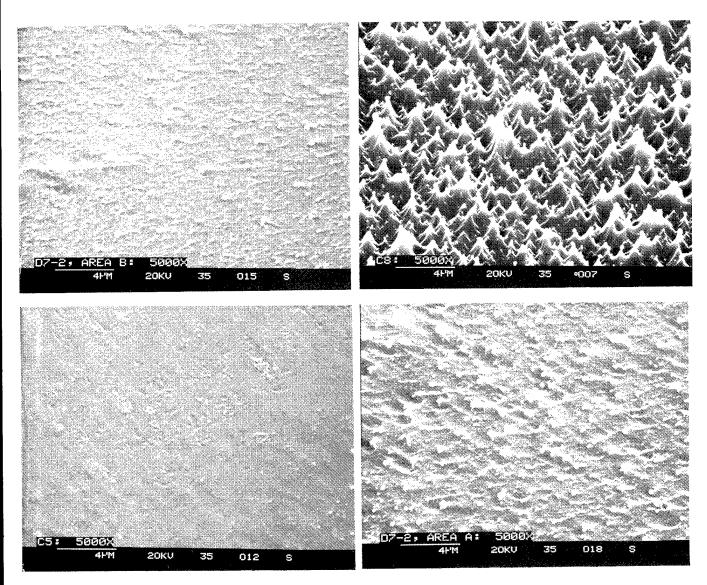
Figure 3. Images From Scanning Electron Microscopy of FEP Surfaces From Selected Thermal Control Blankets

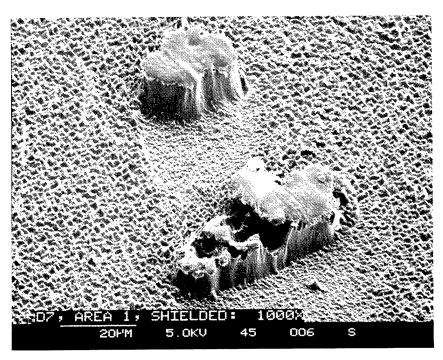
FIGURE 10 Image From Scanning Electron Microscopy of FEP Surface of Specimen From Blanket DO7

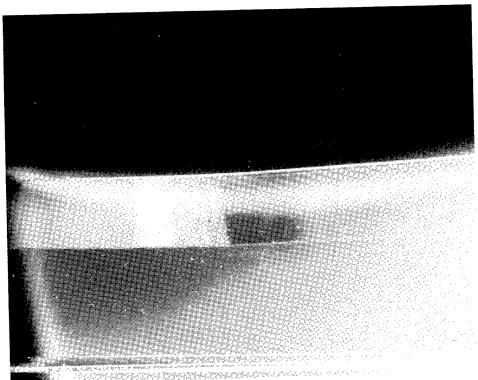
Photograph 2: This is the same sample photographed with oblique toplight. Bands that were dark in Photograph 1 are now bright due to light scatter. Along one edge interference colors can be seen. There are over ten orders of color indicating a thickness of over two micrometers. (See color photograph, p. 1203.)

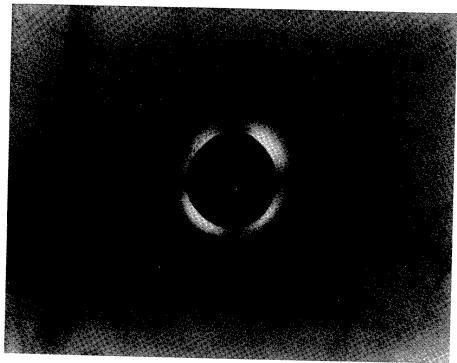
Photograph 4: Transmitted cross polarized light with a first order compensator plate was used to indicate the compressive stress frozen in the Teflon at this impact site. Transmitted illumination at a magnification approximately 300X. (See color photograph, p. 1204.)

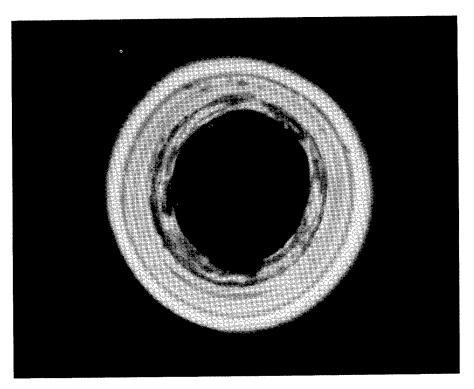
Photograph 5: Transmitted circular polarized light photograph of another impact site exhibiting very high residual stress. Transmitted illumination at a magnification approximately 125X. (See color photograph, p. 1204.)

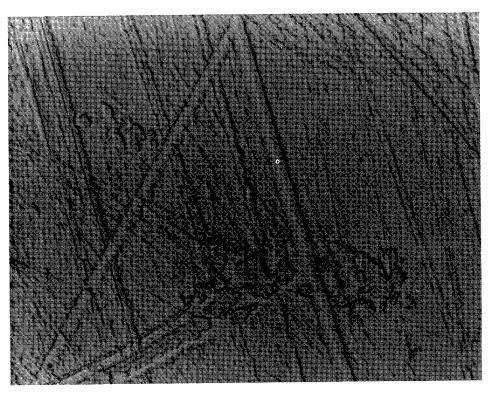
Photograph 6. Front surface of trailing tray A-04, Teflon surface exhibiting UV degradation. Transmitted illumination at a magnification approximately 550X.

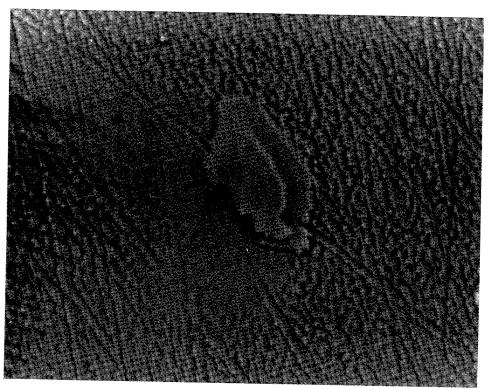
Photograph 7: Microenvironmental effects of atomic oxygen reflected from a trunnion shield back onto the Teflon surface of tray A-04, a trailing tray. Transmitted illumination at a magnification approximately 1000X.

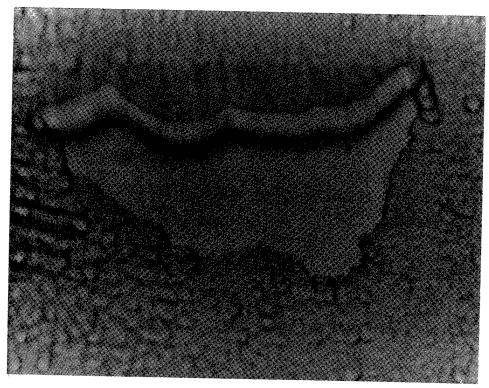
Photograph 8: Very shallow angle etch pattern area on tray C-08. Transmitted illumination at a magnification of approximately 250X.

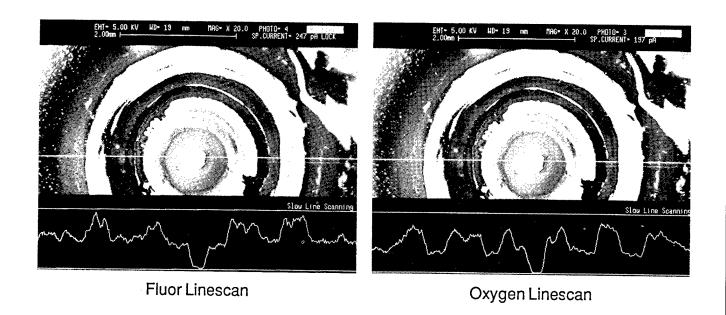
Figure 12. IMPACT HALO ON E10 FOIL

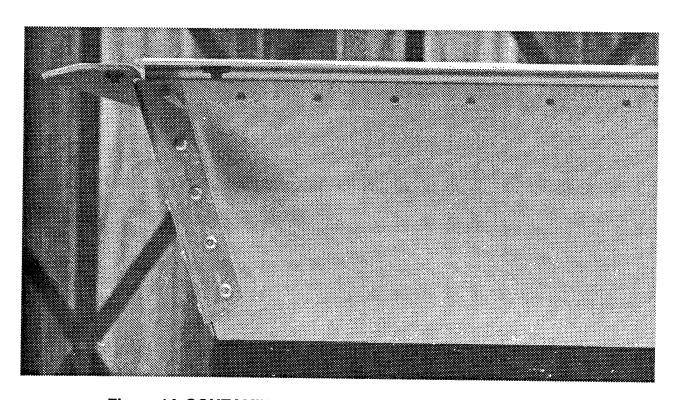
Figure 14. CONTAMINATION STAIN ON TRAY C11 EARTH SIDE

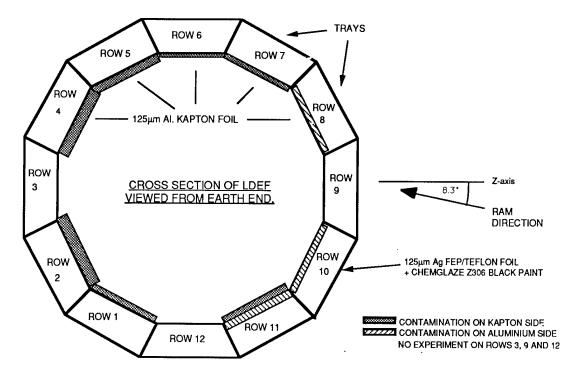
If one indicates on a cross-sectional view of the LDEF (figure 21) which foils were contaminated, making the stripe proportional to the estimated amount of contamination, one can see that the foils in rows 8, 10 and 11 were contaminated on the aluminized side and that the foils in rows 1, 2, 4, 5, 6, 7 and 11 were contaminated on the Kapton side. The most heavily contaminated surfaces were the Kapton side of foils 2, 4 and 5 and the aluminized side of foils 8, 10 and 11.

FIGURE 21. VIEW OF LDEF STRUCTURE WITH UHCRE AL KAPTON FOILS HIGHLIGHTED TO SHOW CONTAMINATION

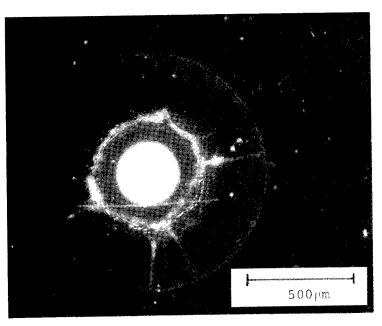
Figure 23. Impact crater. 46 µm glass particle, 7.2 km/s

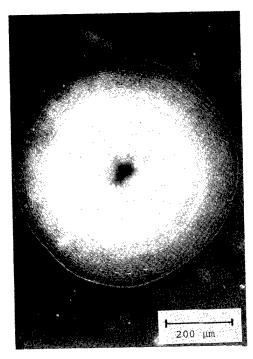
Figure 25 shows the microscopic picture of a very fast impact. At 12.6 km/s, the 71 μ m particle perforated the thermal blanket completely.

Figure 25. Impact crater. 71 µm glass particle, 12.6 km/s

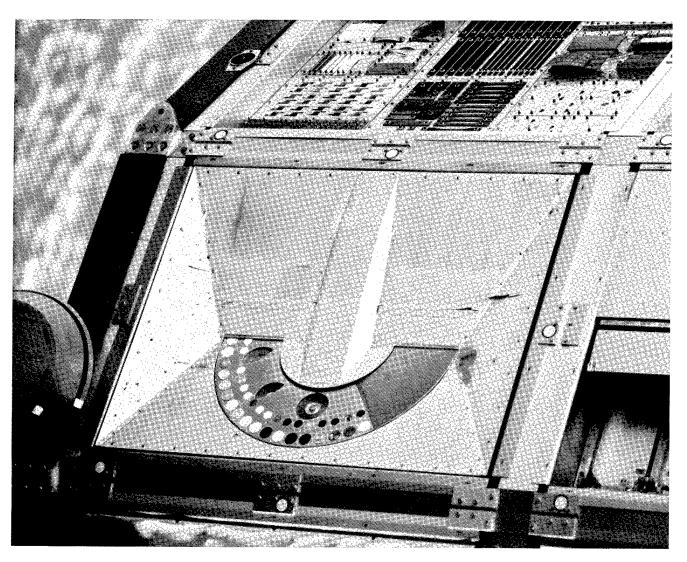
The TCSE operated for 582 days before battery depletion. The battery power was finally expended while the sample carousel was being rotated. This left the carousel in a partially closed position. Figure 3 is a photograph taken during the LDEF retrieval operations showing where the carousel rotation stopped. This carousel position caused 35 of the samples to be exposed for the complete LDEF mission (69.2 months), and 14 exposed for only 582 days (19.5 months) and therefore protected from the space environment for the subsequent four years.

Figure 3 - TCSE Condition during LDEF Retrieval

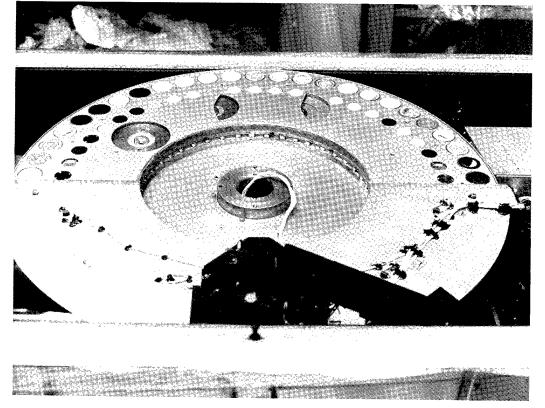
Figure 5 - Post-flight Photograph of the TCSE Flight Samples

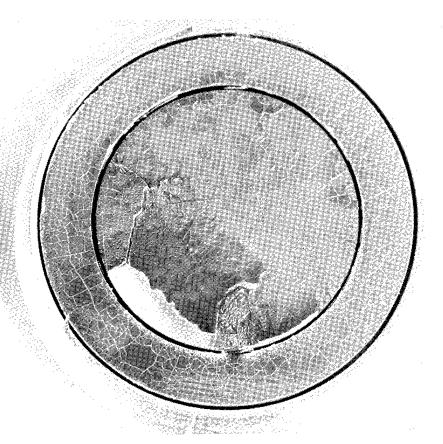
Figure 8 - Post-flight Condition of 0I650 over A276
